Some Water Problems and Hydrologic Characteristics of the UMPQUA BASIN

*by G.L.HAYES and
H.G. HERRING*

PACIFIC NORTHWEST
FOREST AND RANGE EXPERIMENT STATION
U. S. DEPT. OF AGRICULTURE • FOREST SERVICE

JULY 1960

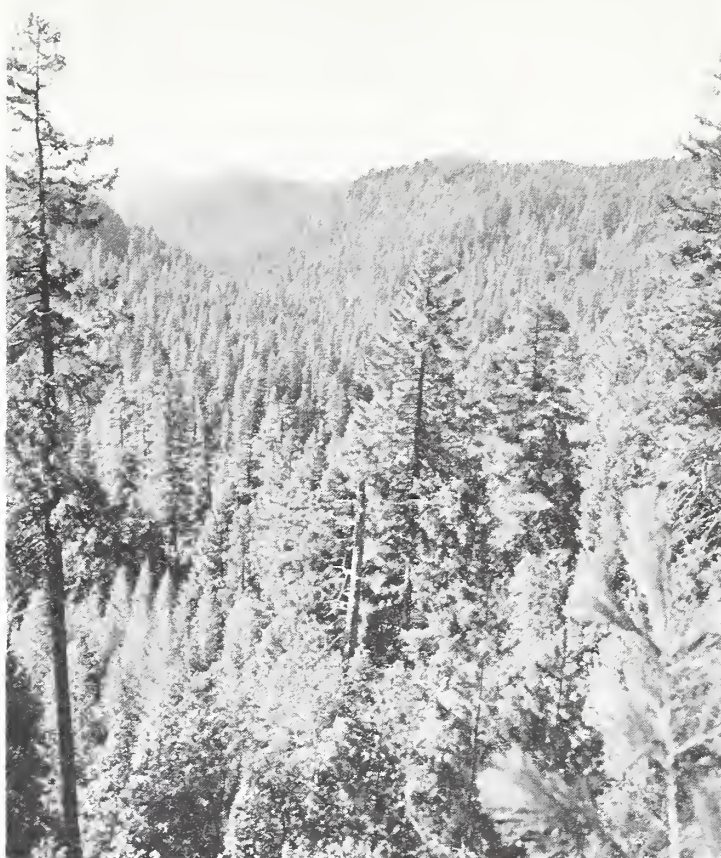
Figure 1.--Typical forest conditions in the older Cascades of the Umpqua Basin.

For the most part, however, the Umpqua Basin is covered with a dense timber stand (fig. 1). As is to be expected, the higher, less accessible parts of the watershed are more completely vegetated than the lower parts. Several forest types are represented, with Douglas-fir being most important. A mixed-conifer type occupies extensive

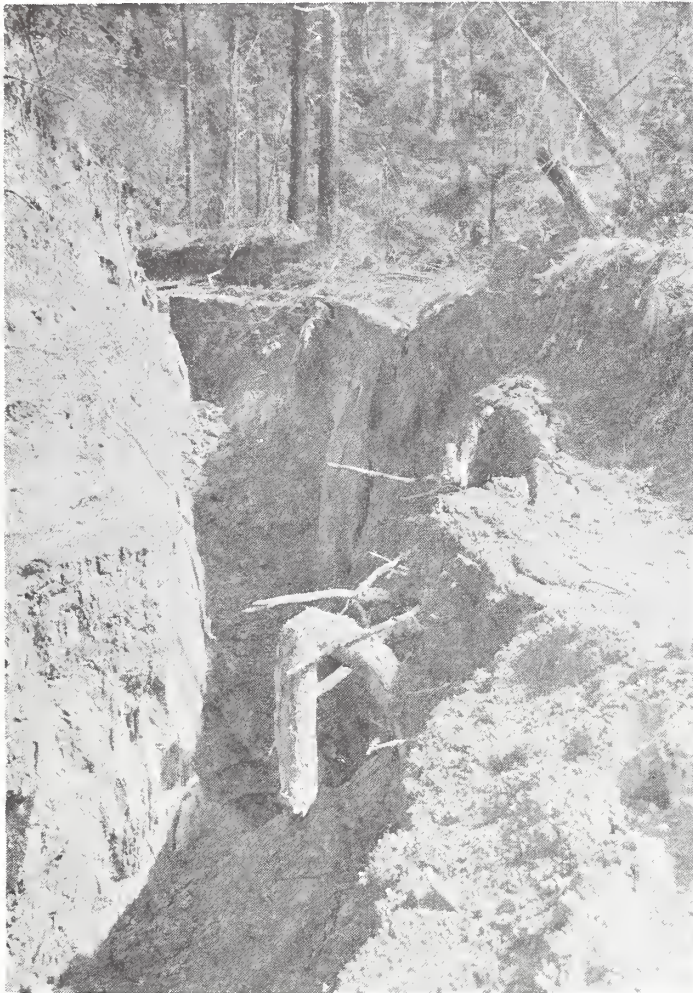
Figure 2.--Erosion caused by concentrated runoff on an abandoned road in pumice soil.

flood and they maintain a good summer flow. Highest flows from such streams are typically only 5 to 50 times greater than the least flows. If an unusual combination of circumstances results in surface runoff, however, pumice will erode rapidly, creating deep, vertical-sided gullies (fig. 2).

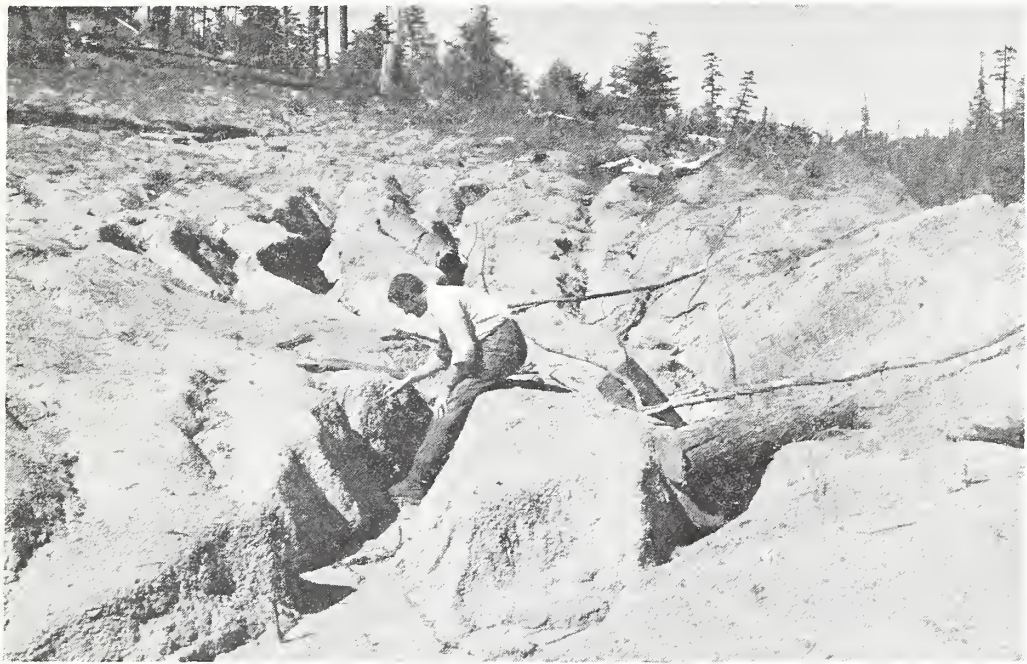
Figure 3.--Quartz diorite soils require special care to avoid overland flow when plant cover is removed.

they will average about the same. The two extremes found in this group are granitoid and ultrabasic intrusions, both of which present serious watershed management problems. The granitoid rock, mostly quartz diorite, weathers to a loamy sand, with high infiltration rates. When subjected to overland flow, however, soils derived from quartz diorite erode rapidly; gullies 3 feet deep are not uncommon (fig. 3).

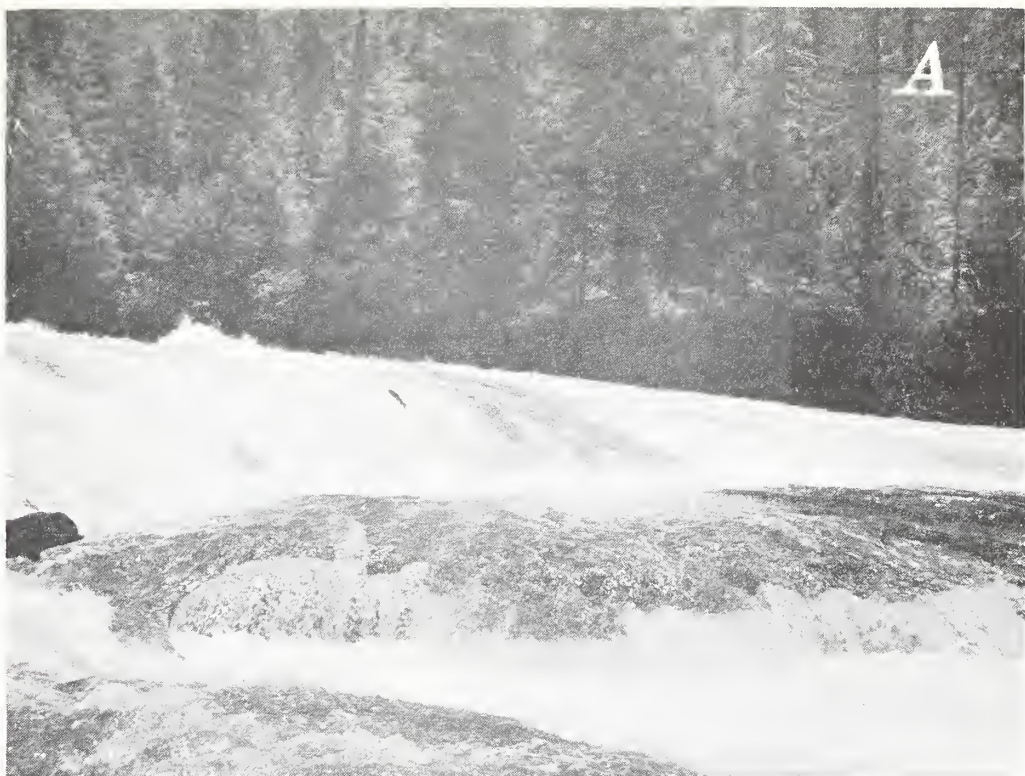
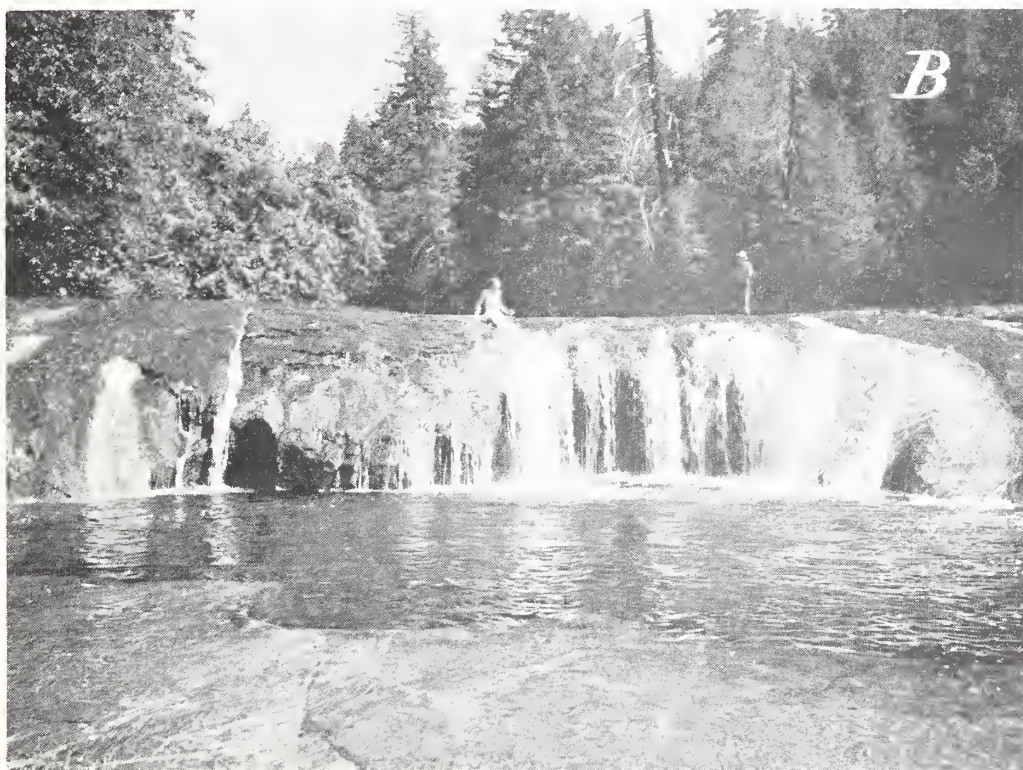
Figure 4.--Flow at the South Umpqua Falls in June (A) declines considerably by September (B). Drainage area above the falls is about 6 percent of the drainage area above Roseburg.

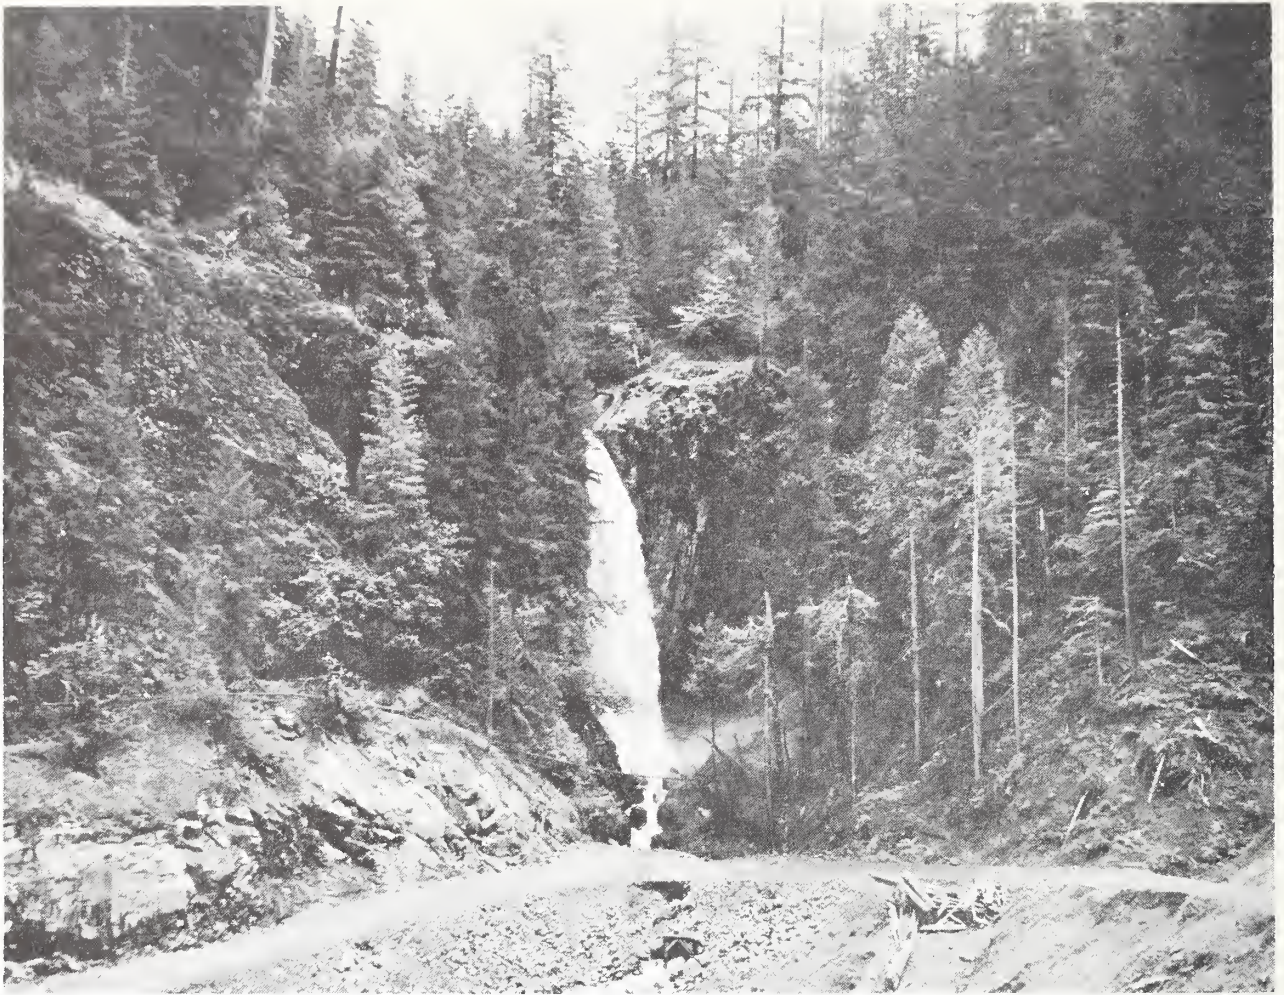
Figure 5.--A small snow-fed tributary of the North Umpqua River during the spring runoff.

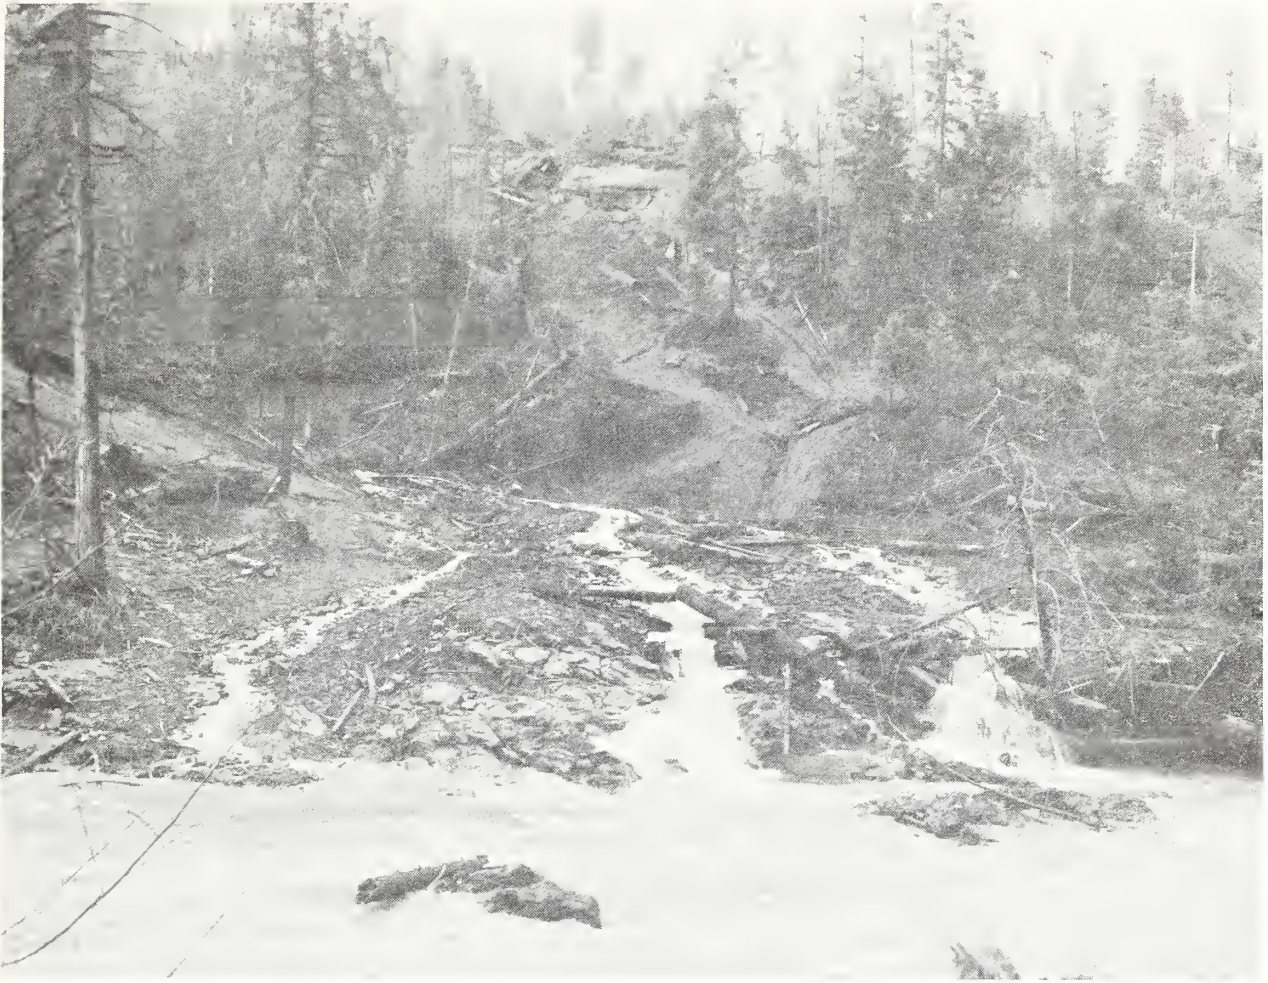
Figure 7.--When landings are located adjacent to streams, there is no opportunity for filtration of sediment-laden water before it reaches the stream.
